**Precise Home Inspection Services, LLC**

***Residential Home  
INSPECTION REPORT  
For***

***Dave & Carol Whitney  
13515 81st Ave. NE. Arlington, WA. 98223***

Date: September 10, 2011

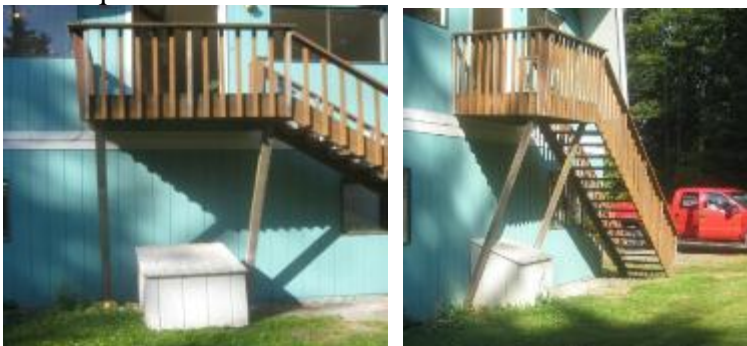
1. The construction of the exterior garage wood deck and access stair way structure does not meet or comply with industry standards. The stair structure does have adequate vertical support along with improper stair tread design. This is a safety hazard and should be corrected immediately. Contact a qualified contractor to make all modifications and repairs as needed to meet safe building standards.

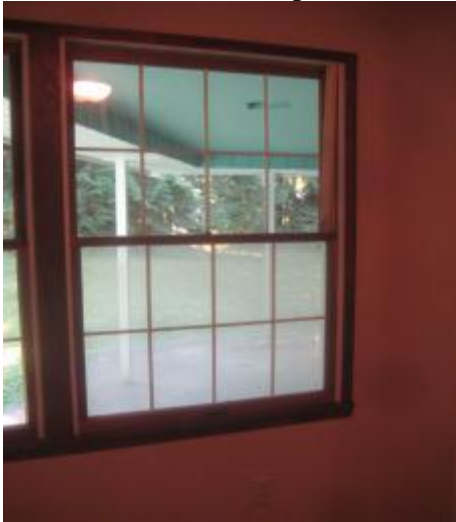
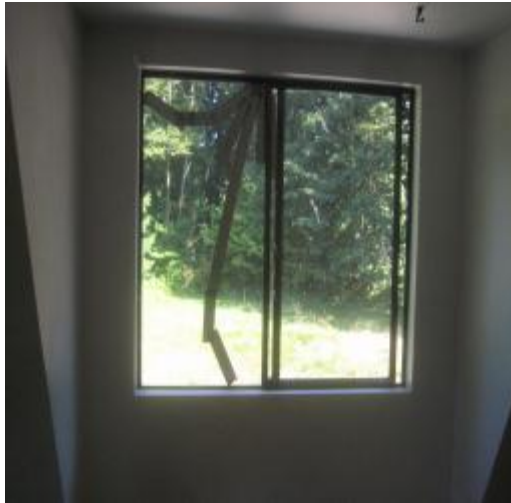
2. The east exterior garage entry wood porch decking and stair tread boards are covered with algae, making the deck surface very slick and could be a safety hazard. The wood deck materials show early signs of decay and weathering. Recommend all splintered, and or damaged decking boards be repaired or replaced. The deck should be treated with a quality weather proofing sealant or stain.
3. The east living room insulated window seals have failed. The NW garage window lens is broken. Recommend replacement or all damaged windows as needed.

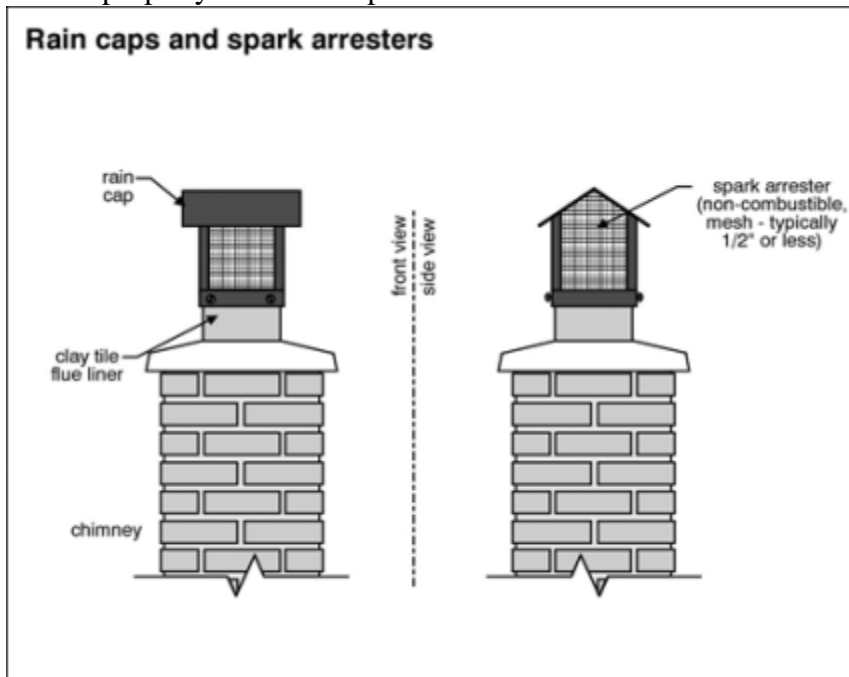
4. The exterior brick chimney flue vent is not covered with a weather cap. Recommend a weather cap be properly installed to prevent rainwater and debris from entering the chimney stack.

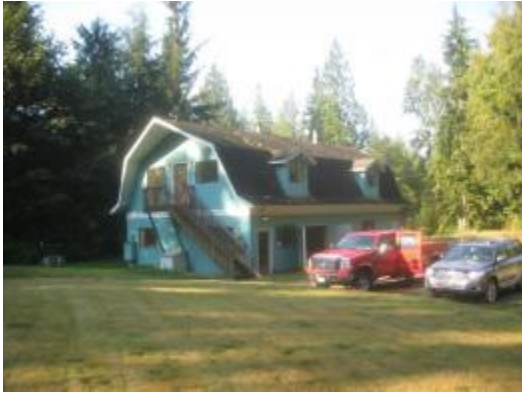
1. The grounds are well drained with no signs of standing water or erosion of top soils noted at the time of this inspection.

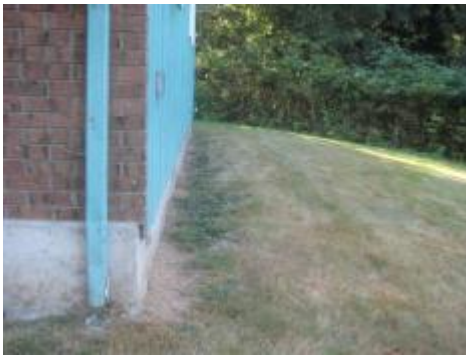
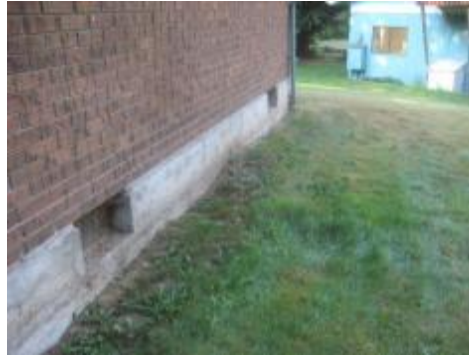
2. There are several large depressions along the foundation walls. The grounds and landscaping will require leveling and contouring to prevent erosion and promote proper drainage away from the foundation wall.

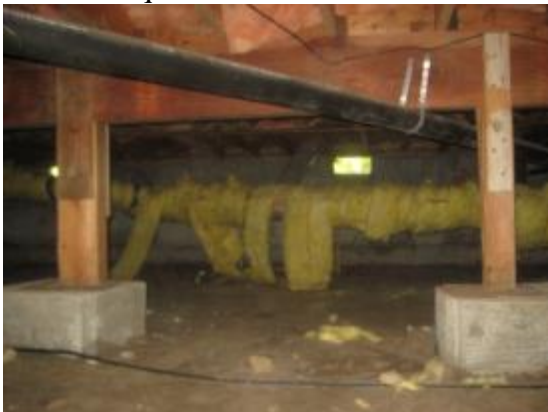
1. The presence of rodent pellets indicates that rodents are nesting in the insulation. No current or active use of rodents was observed. Recommend a pest control specialist be contacted to remedy the infestation of rodent. All sources of possible rodent access must be covered and or secured. All damaged insulation should be removed and replaced. Recommend all fecal matter and soiled plastic sheeting (visqueen moisture barrier) be removed and replaced with clean black 6mil. Plastic visqueen. The preferred material for use as a vapor barrier is 6 mil black polyethylene, often referred to as visqueen.

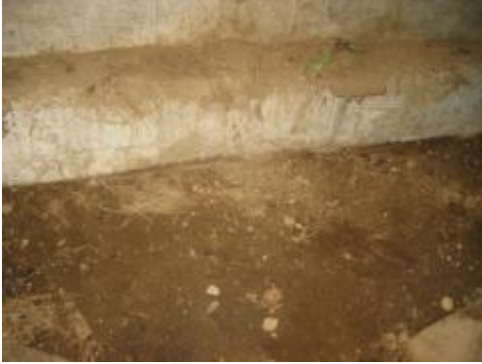
2. Portions of the soil in the crawl space are not covered by vapor barrier (plastic sheeting). A vapor barrier helps reduce moisture levels in the crawl space. Exposed damp soil creates conditions conducive to various wood destroying organisms. The redistribution or installation of additional vapor barrier material to cover the exposed soil in the crawl space is recommended. The preferred material for use as a vapor barrier is 6 mil black polyethylene, often referred to as visqueen.

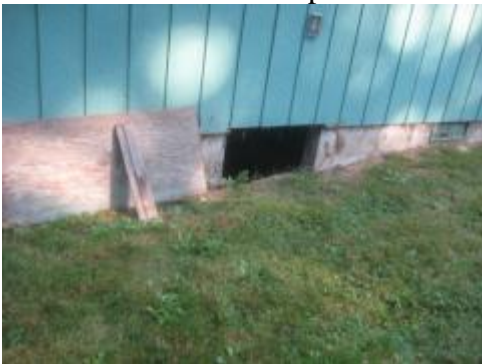
3. The crawl space access portal covers are not flat fitting and not weather proofed. Recommend the installation of a new crawl space access cover that slopes slightly (2%) away from the house and fits securely to prevent entry from pets or rodents, and wind driven rain from entering the crawl space. The cover should have a fastening device (no locks). The cover must slope away from the structure and have a moisture proof cover

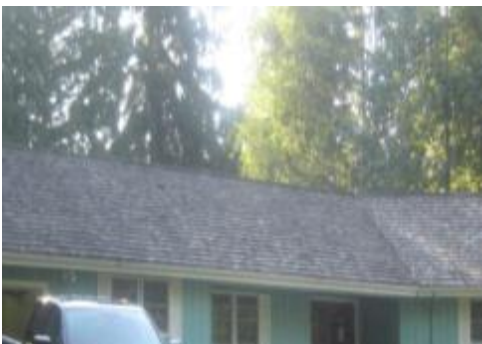
1. Many of the cedar shakes are either missing, deteriorated, and/or broken. This roof is near the end of its useful life. The roofing should be removed and replaced with suitable roofing materials. Contact a licensed roofing contractor to determine options and cost to repair/replace the roof. Recommend additional roof vents be installed when the new roof is installed.

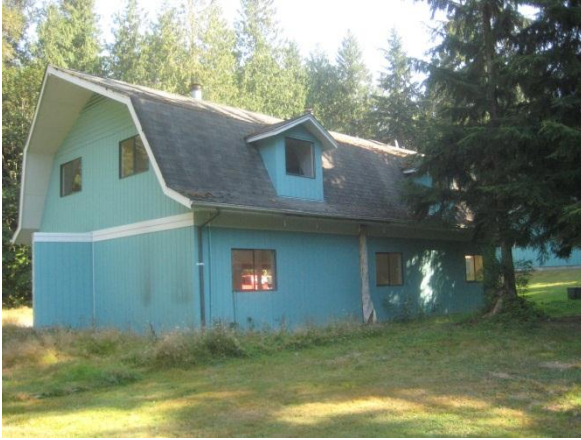
3. The garage roof and rain gutters are full of moss, tree needle and leaf debris. The gutters need to be cleaned of all debris to allow the gutter system to function properly. The gutter runs will need to be cleaned and kept clean to prevent debris clogging the scuppers causing water and ice damming.

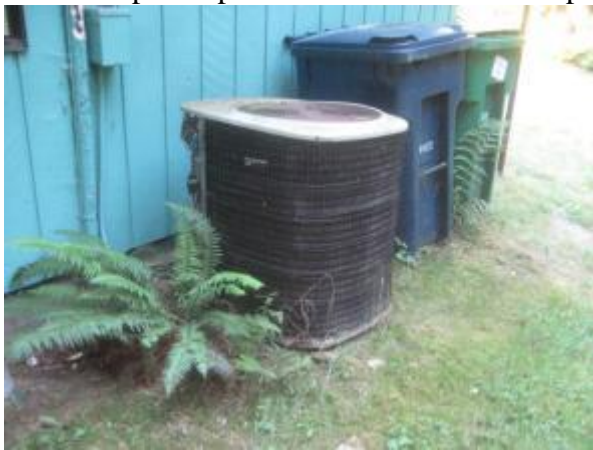
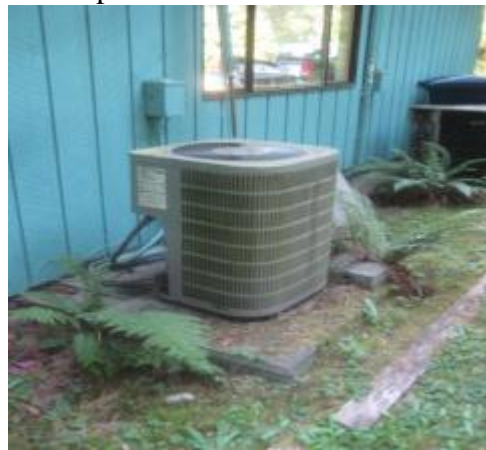
1. The two exterior heat pump units are not operational. The Units are older and should not be considered usable. The older (west) unit, will need to be replaced. The newer (east) unit has potential for repairs. Recommend contacting a qualified HVAC contractor to service all heating and cooling appliances. Anticipate replacement of the Heat Pumps, with repairs to the electric furnaces.

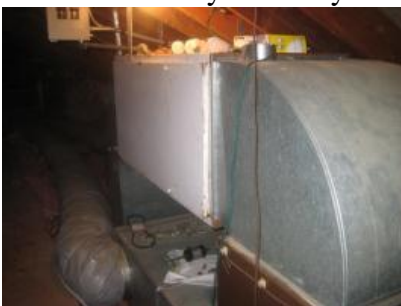
2. There is no current maintenance record for the electric furnace. Due to the age of the electric furnaces, I recommend the heating and cooling system be examined by qualified technician and make repairs if necessary to certify it to be in a safe and good working condition prior the next heating season.

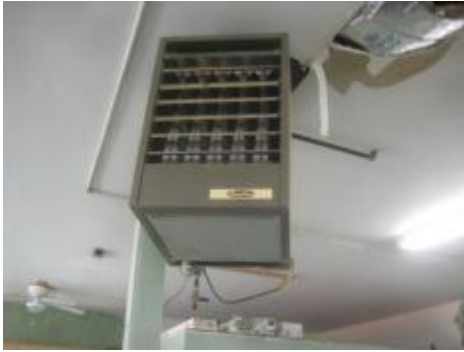
3. The propane gas tank had been removed preventing the inspection of the garage heating system. The electric baseboard and wall inserts where all working at the time of this inspection. Recommend the installation of a double or triple lined heat exhaust pipe to comply with current safety standards.

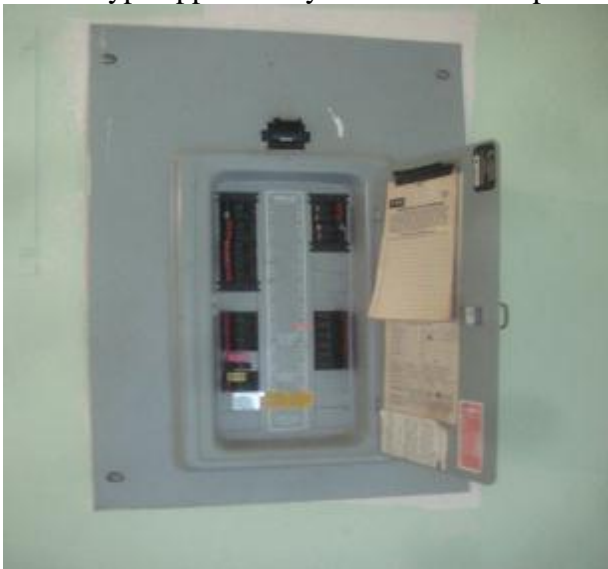
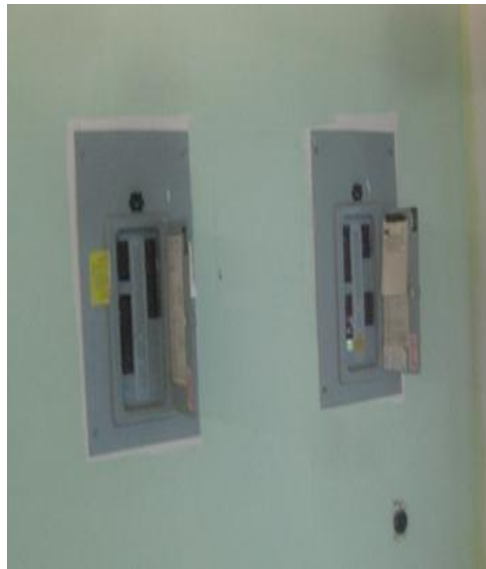
1. There are many improper and unsafe electrical installations throughout the house and garage. The following deficiencies should be corrected by a qualified electrician. Recommend a qualified electrical contractor be contacted to correct all defective and improper wiring as needed to bring the electrical system up to current NEC 2000 code requirements.

- Defective lighting fixtures,
  - Open wall receptacles,
  - Exposed (no cover plates) wiring at wall outlets and switch boxes.
  - Installation of “Magnastrip” main electrical panel. Open circuit breaker blanks.

- Improper circuit mapping at main circuit panel box.
  - No GFCI outlets installed in kitchen and bathrooms.
2. The “Magnastrip” brand name, of electrical main panel has had problems with corrosion on the aluminum panel bar and welding of the side of the box because the breakers failing to trip. This condition has been the source of documented home fires. Contact a qualified electrical contractor to inspect the complete electrical system and report all deficiencies and make any repairs that may be necessary. Recommend the main electrical panel with all components be replaced and updated to a type approved by the NEC 2000 specifications.

Main house circuit panel located in garage. Note: two panels to service main house electrical

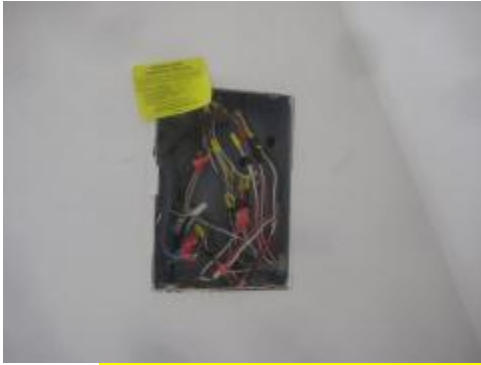
3. Open junction box with no circuit breaker protection installed in Garage living quarters. This situation needs immediate attention and corrective measures made by a qualified electrician ASAP.

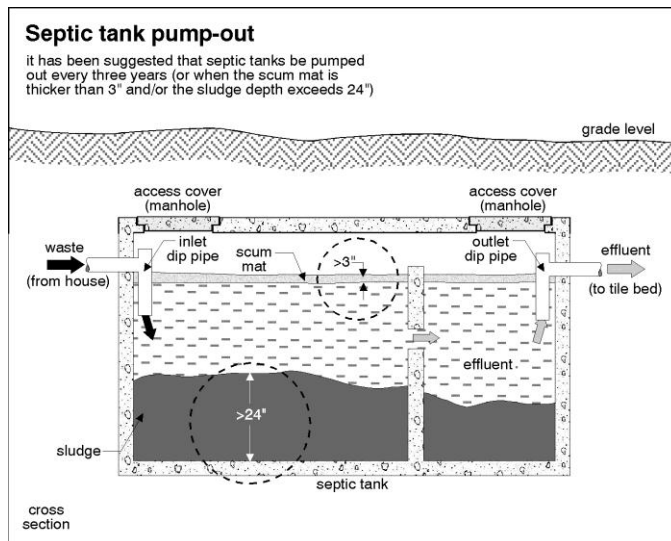
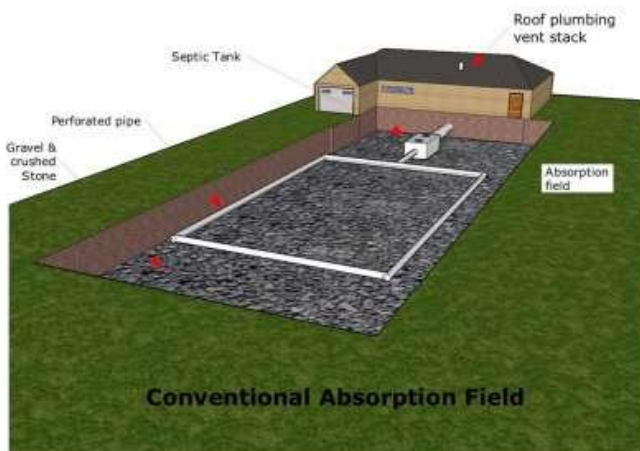
1. The sewage and waste management system is privet septic system. Testing and inspection of this system is outside the scope of this inspection. Recommend a qualified well and plumbing contractor be contacted to test all well, pump, and related components and certify the system in good working condition. Recommend a potable water quality analysis be made by a qualified test lab.

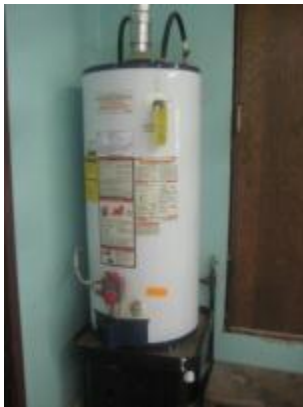
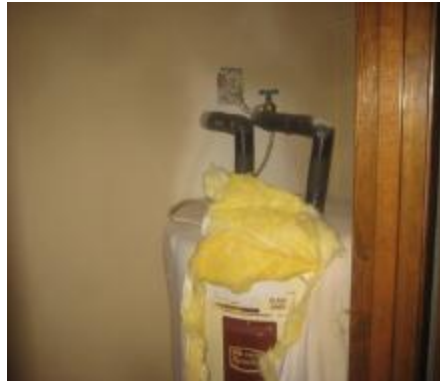
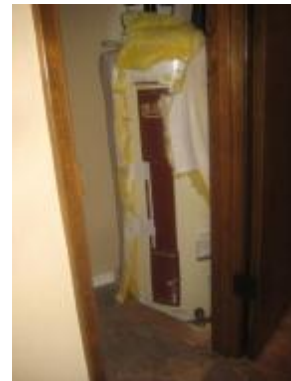
- North water heater (garage)                      South water heater (hallway closet)

3. The home has two electric water heaters with one gas water heater located in the garage. The hot water appliances were found to be in operational condition. However; the 2 house electric 40gal. water heaters are older (15+ years) far past the designed service life of the appliance. Anticipated replacement in the near future.

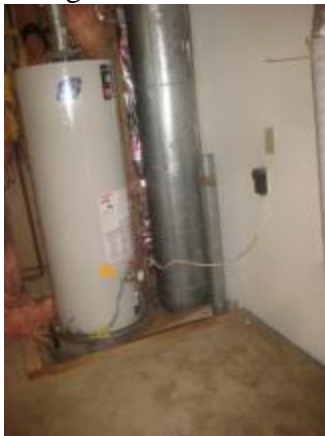
Garage water heater

Garage water is newer, 5-6yrs. Installation of gas lines should be guarded.

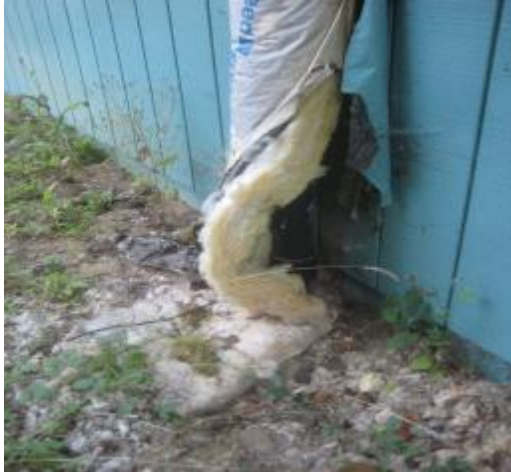
6. The garage main sewer drain line is installed outside the exterior wall. This is a conventional installation. Recommend the insulation is secured to exposed pipe to reduce exposure to cold temperatures. Relocation to interior wall is recommended.

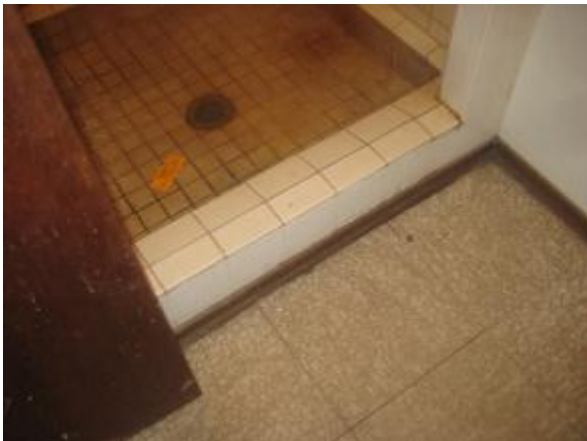
1. The garage bathroom vinyl flooring has lifted from the floor decking adjacent to the shower stall indicating the presence of moisture between the vinyl and wood floor decking. All rooted wood and materials must be removed and replace with suitable materials. Recommend a qualified contractor be contacted to determine the extent of repairs needed to correct this situation.

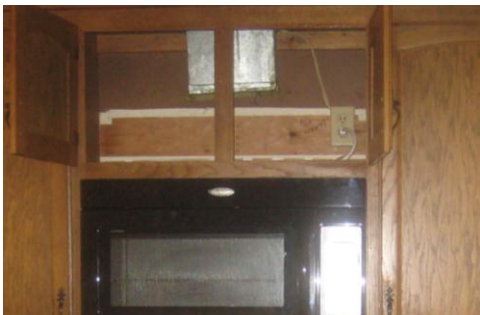
1. The house kitchen microwave overhead exhaust vent is not connected to ceiling duct. Repair duct connection as needed. The kitchen appliances are aged anticipate replacement in the near future.
